OAK RIDGE NATIONAL LABORATORY
Operated by
UNION CARBIDE NUCLEAR COMPANY
Division of Union Carbide Corporation

ORNL
CENTRAL FILES NUMBER
58-11-44

DATE: November 17, 1958
SUBJECT: Fallout from 3505 Metal-Recovery Stock
on Malan Contractor's Area, Jan. 17, 1956.
TO:
FROM: W. W. Ogg

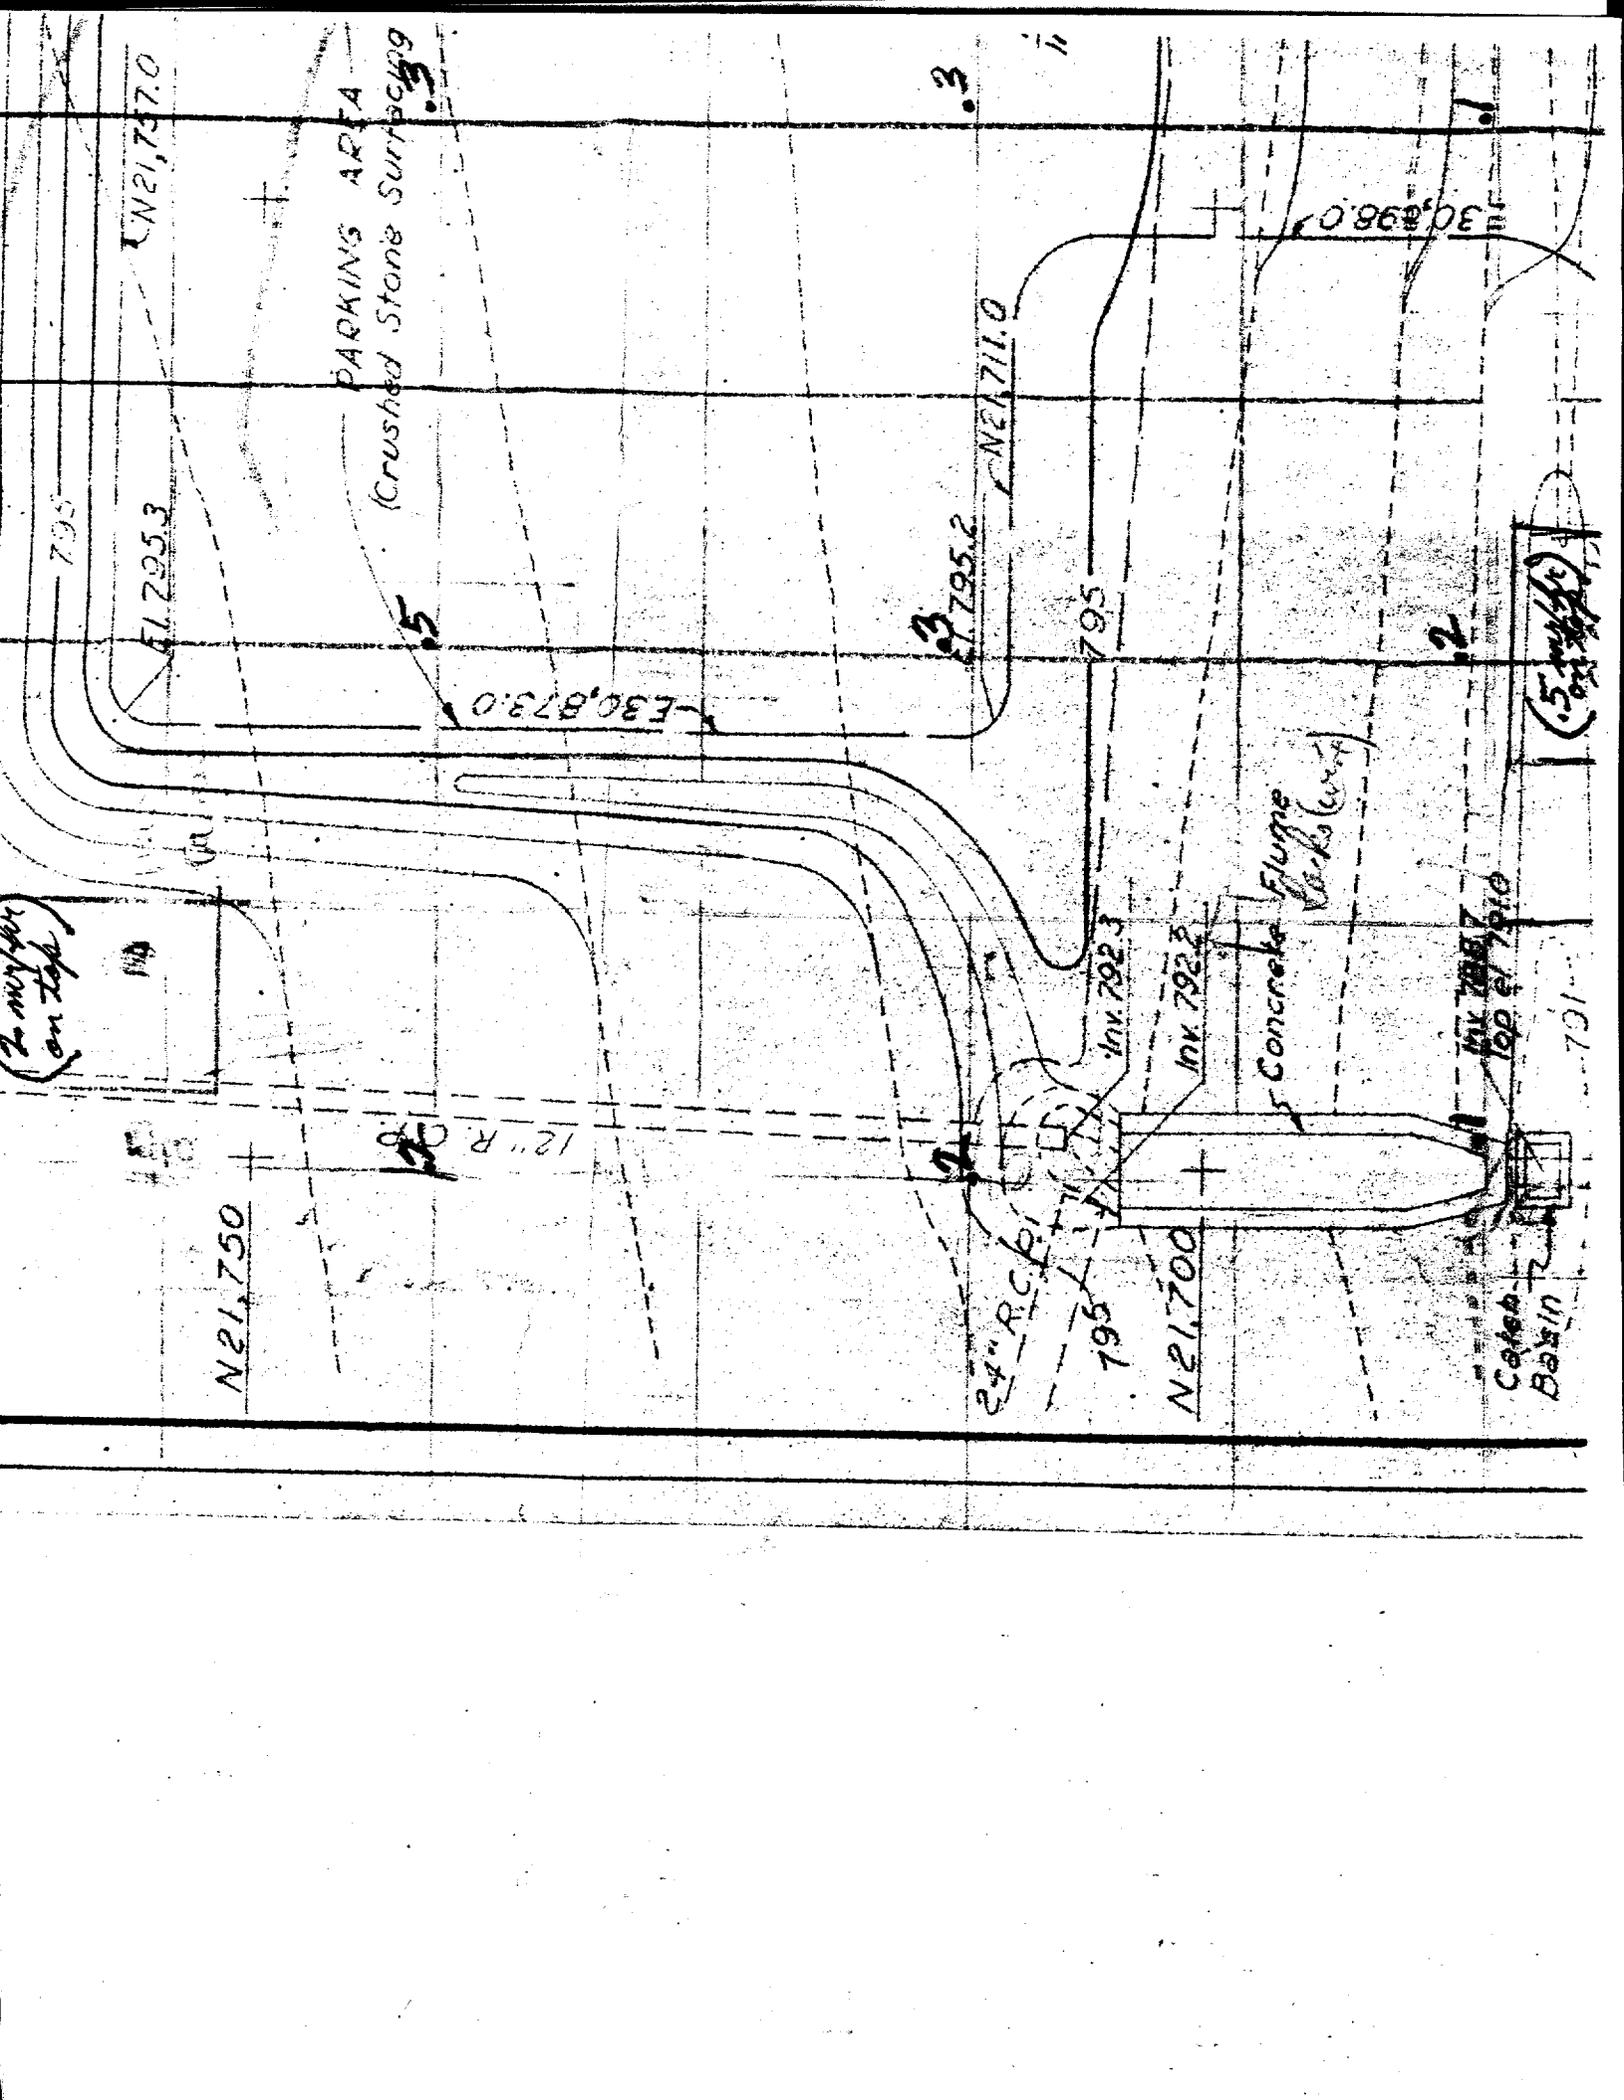
The read ink figures are my Mr readings above background for each particular location taken on ground level with GMSM.

All samples taken for 3 min @ 4500 c.c./min of air.
Wind - light (0-5 mph), variable NW to SW.
1-18-56 P.M.

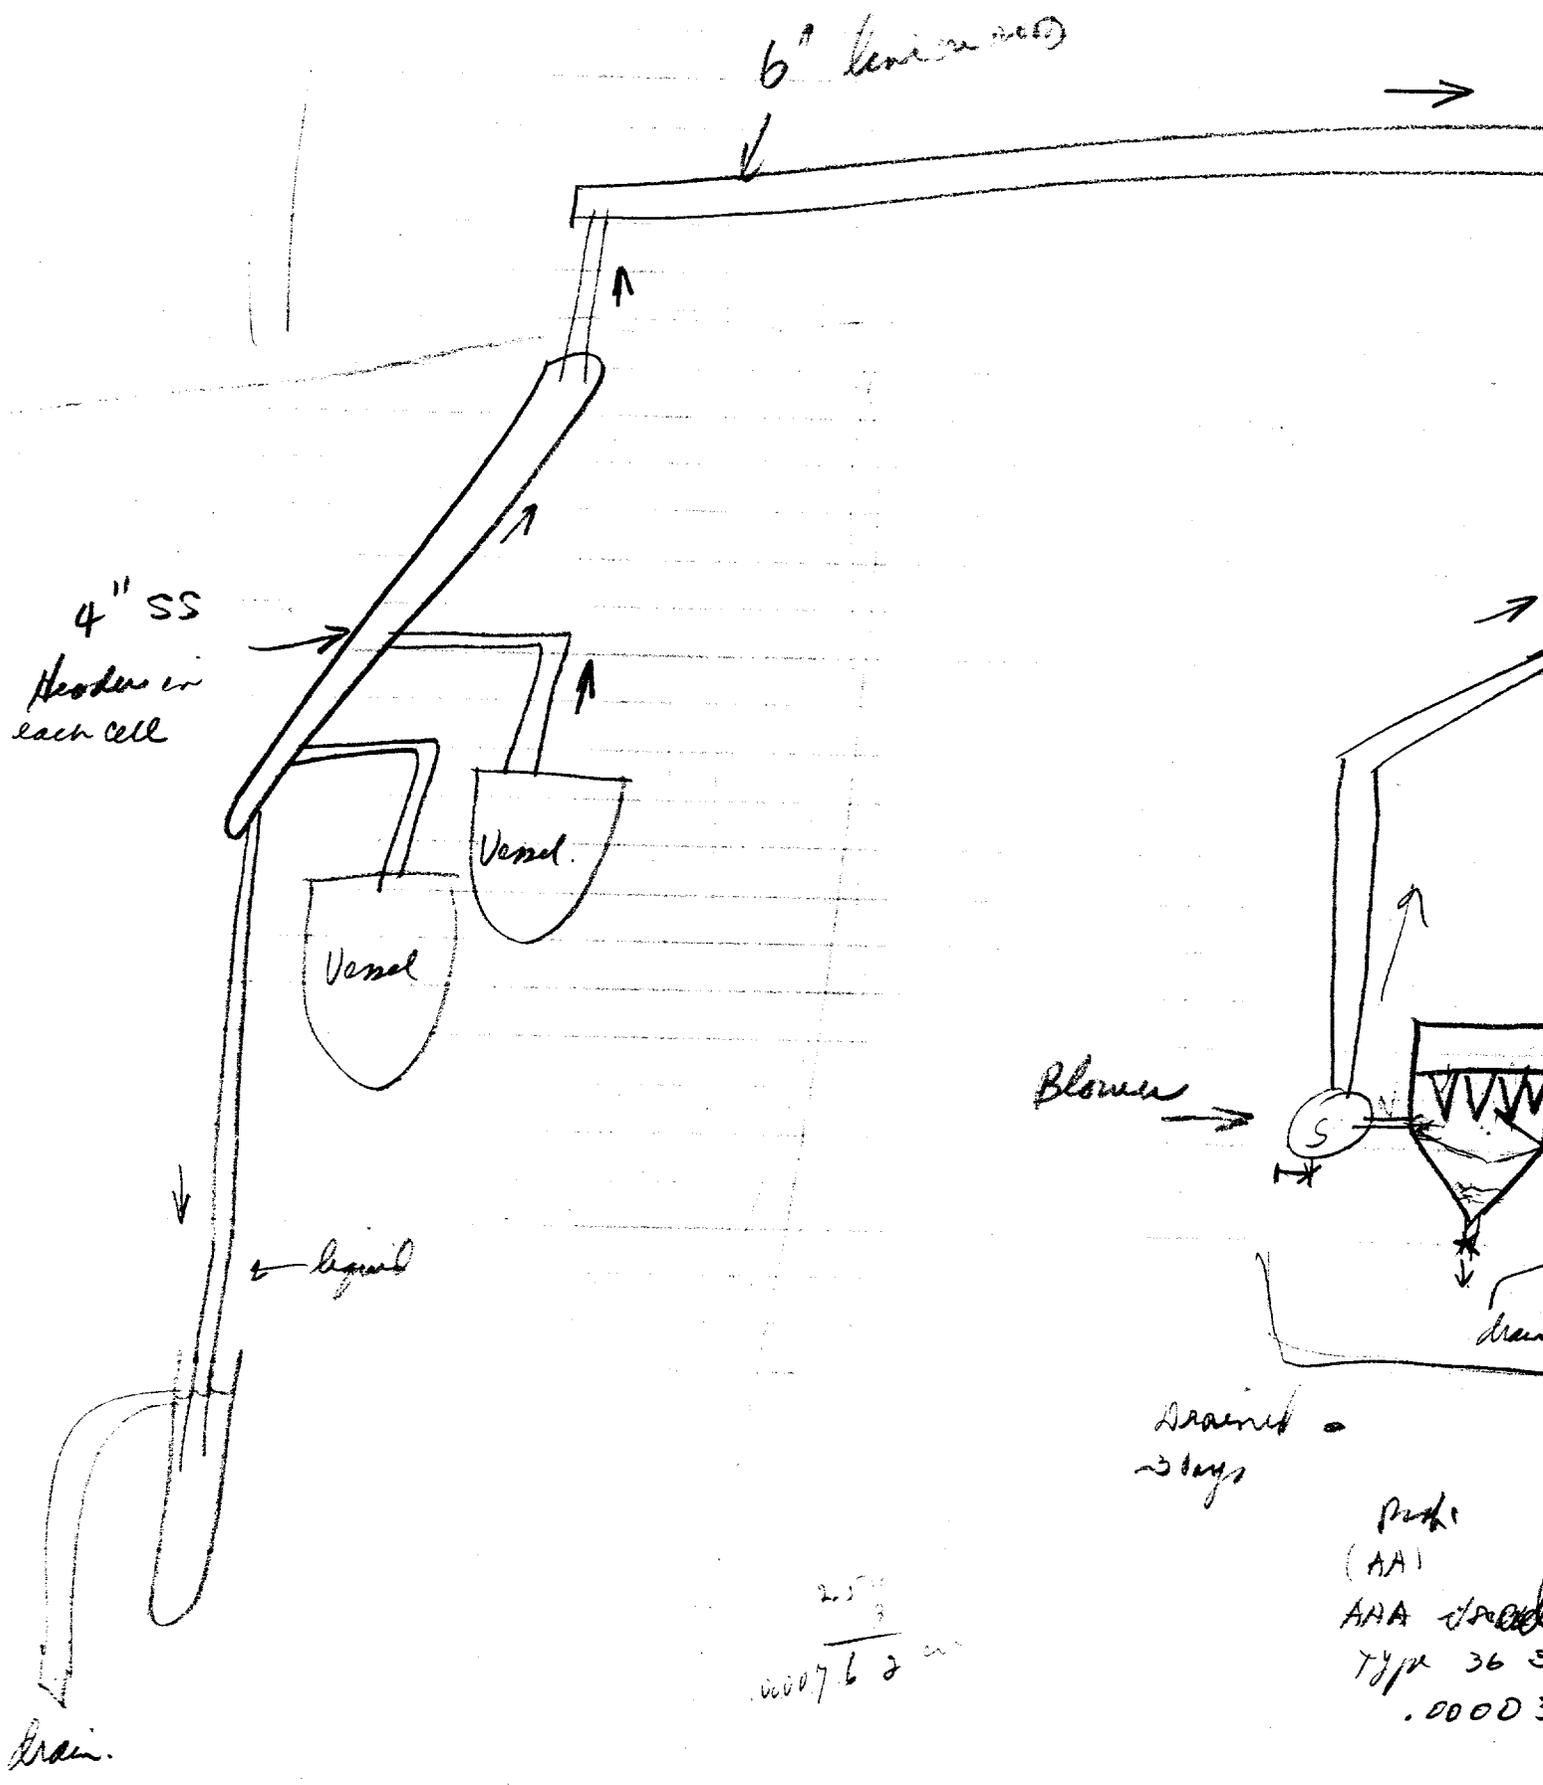
3505 FILTER SYSTEM

1. using filter at $\sim 2\frac{1}{2}$ times rated capacity
rated 1000cfm - using at $\sim 2500cfm$
2. NO gasket seals on filters
3. Flow through filters should be reversed
4. what appeared to be a cyclone separator
is only a liquid trap.
5. Efficiency of filter media - unknown
6. HNO_3 fumes seen emerging from stack
when power is shut down & started up.
Proposed by Lewis & c - - ?

1. Reduce vacuum from 6" to 3' - to
cut down flow through system
2. Install home-made cyclone
instead of liquid trap.
cyclone to have charcoal bed included
~~in parallel~~
